Smoke and Dye Testing Summary

High Level Sewershed

Test ID	Test Type	Date Inspected	Company / Super.	Blower MH	Ground Condition	Notification Made?	Total Length
S1028-268	Smoke	9/2/2009	ADS/TM	S11MM1029MH	Dry	Yes	802.14

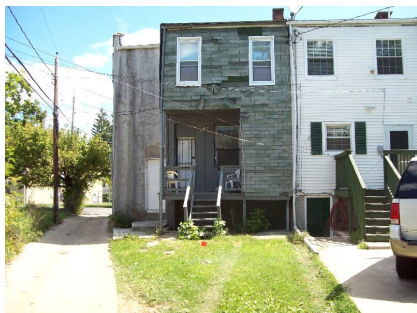
Picture \S1028-268-OB01-P01.jpg

Comments Smoke from cleanout in back yard. 4734 Pimlico Rd.

Comments Back of house, 4734 Pimlico Rd.

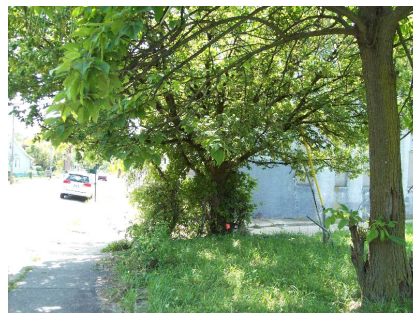
Picture \S1028-268-OB02-P01.jpg

Comments Smoke from cleanout in empty lot. 3003 Woodland Ave.

Comments Back of lot, 3003 Woodland Ave.

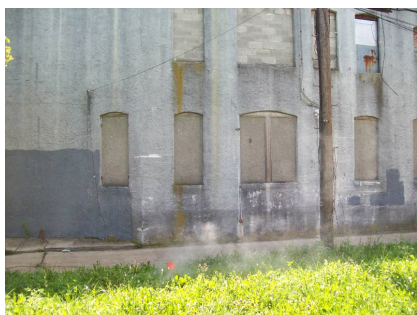
Picture \S1028-268-OB03-P01.jpg

Comments Smoke from cleanout in empty lot. 3005 Woodland Ave.

Comments Back of lot, 3005 Woodland Ave.

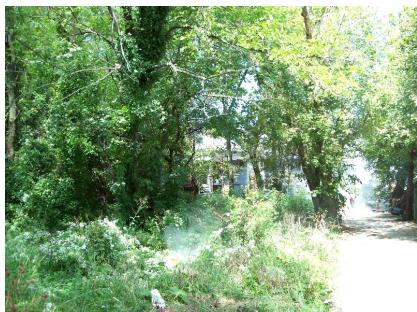
Picture \S1028-268-OB05-P01.jpg

Comments Smoke from cleanout in empty lot. 4721 Delaware Ave.

Comments Back of lot, 4721 Delaware Ave.

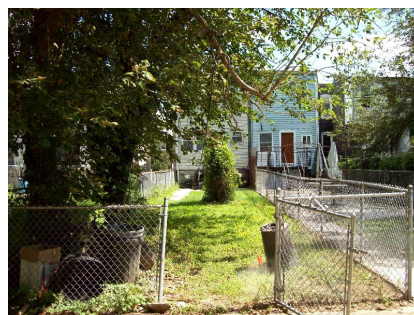
Picture \S1028-268-OB04-P01.jpg

Comments Smoke from service lateral in back yard. 4722 Pimlico Rd.

Comments Back of house, 4722 Pimlico Rd.

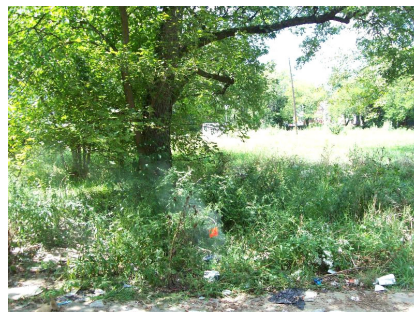
Picture \S1028-268-OB06-P01.jpg

Comments Smoke from cleanout in empty lot. 4709 Delaware Ave.

Comments Back of lot, 4709 Delaware Ave.

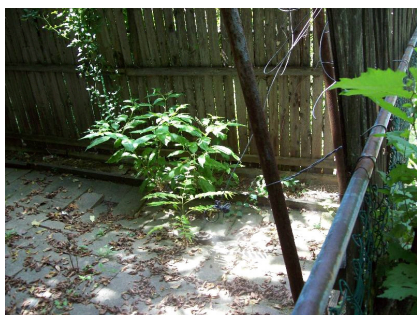
Picture \S1028-268-OB07-P01.jpg

Comments Smoke from service lateral in paved area behind house. 3114 Virginia Ave.

Comments Back yard, 3114 Virginia Ave.

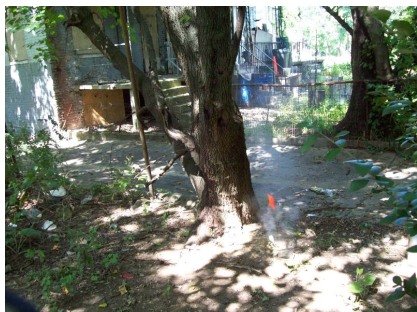
Picture \S1028-268-OB09-P01.jpg

Comments Smoke from cleanout in back yard. 3122 Virginia Ave.

Comments Back of house, 3122 Virginia Ave.

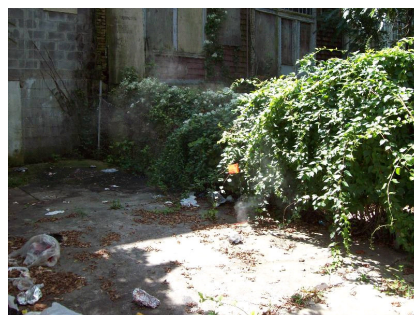
Picture \S1028-268-OB08-P01.jpg

Comments Smoke from cleanout in paved concrete behind house. 3102 Virginia Ave.

Comments Back of house, 3102 Virginia Ave.
